**Company Name:** Windsor Road (Swindon) Residents Limited

**Inspector Name:** Thomas Dellow MIRPM

**Inspection Date:** 30 November 2023

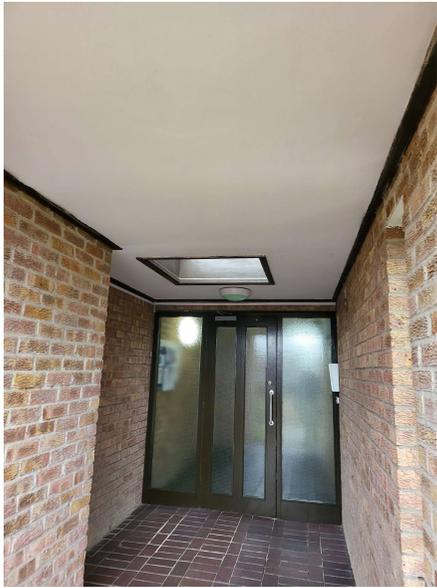
**Entrances (Main Doors)**

Internal Inspection	Acceptable	Not Acceptable	N/A	Comments	Action
<b>Entrances</b> (Main doors)	✓			Entrances to each block are secured via fob entry and were secure.	None
<b>Hallway</b> (Communal Lobbies and Stairs)		✓		Items were being stored in the communal hallway. These items will be ticketed/ owners notified and removal arranged.	Review
<b>Lighting</b> (Standard and Emergency Lighting)	✓			The lighting appeared in good visual condition.	None
<b>Internal Doors</b> (Compartment Doors)	✓			Compartmenting doors appeared in good visual condition and operation.	None
<b>Cupboard Doors</b> (Electrical Cupboard Doors)	✓			The electrical cupboard doors were secure.	None
<b>Windows</b> (Communal Windows)	✓			The communal windows appeared in good visual condition.	None
<b>Signage</b> (Communal Notices)	✓			Signage was present and up to date.	None
<b>Additional Comments</b>					None

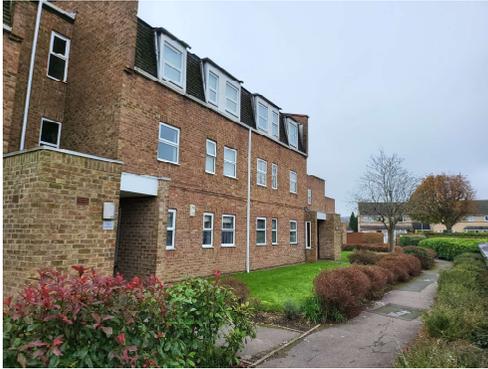
**Exterior Structure (The Building)**

External Inspection	Acceptable	Not Acceptable	N/A	Comments	Action
<b>Exterior Structure</b> (The Building)	✓			The exterior was visually inspected and appeared in good condition.	None
<b>Guttering</b> (Gutters and Fascia)	✓			The guttering was visually inspected and appeared in good condition.	None
<b>Roofing</b> (Tiles and Cladding)	✓			Due to height constraints the roof was visual inspected from ground level and appeared in good condition.	None
<b>Communal Grounds</b> (Gardens and Common Areas)	✓			The communal grounds appeared in good visual condition. The gate closest to Highclere Ave has been vandalized, contractor to make repairs.	Review
<b>Bin Store</b> (Waste Disposal Areas)		✓		There are a small number of non domestic waste items which require removal. The bin store is otherwise satisfactory.	Review
<b>Car Park</b> (Vehicle Parking)	✓			The car park was accessible.	None
<b>Bike Store</b> (Bicycle Areas)	✓			The bike stores were generally accessible except for 20-25. The owner of the items will be contacted.	Review
