# COMBINED FIRE AND HEALTH & SAFETY RISK ASSESSMENT.

| Address of premises: | 1-34 Broughton Grange<br>Highclere Avenue<br>Swindon<br>SN3 1LW |
| Date of fire risk assessment: | 5 <sup>th</sup> November 2025 |

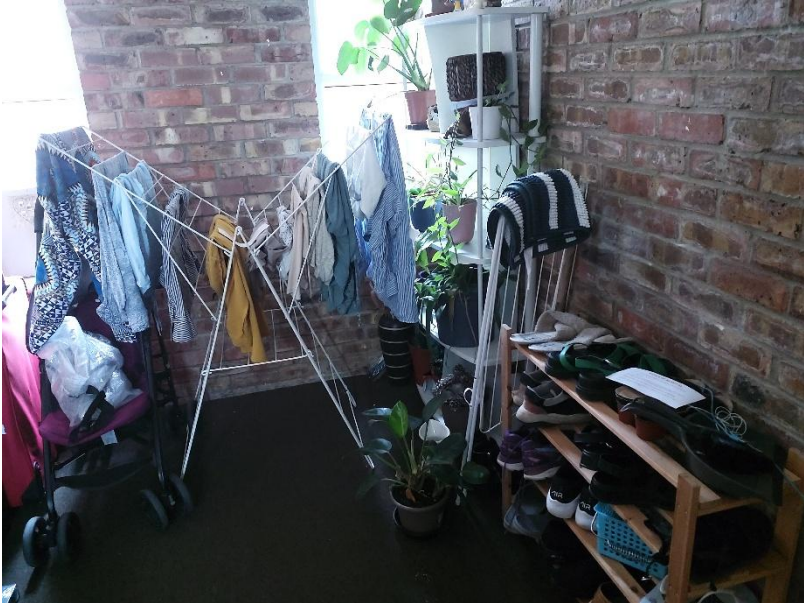
| Item | Recommendation | Priority | Timescale | |
|---|---|---|---|---|
| 02 | <p>Housekeeping was found to be of a poor standard at the time of this assessment within entrance 1-4 and 32-34 with the communal areas and escape routes congested with residents' possessions and storage. It is recommended that the client arrange for the communal areas to be cleared as a priority and all residents reminded of the importance of maintaining sterile communal areas and escape routes.</p> | 2 | B | <p>Ongoing action required</p> <p>DH inspect communal areas and ticket items for removal.</p> <p>Residents are reminded to keep a sterile communal area via notice board and website.</p> |

| <p>Housekeeping was found to be satisfactory at the time of this assessment within entrance 5-8, 9-13, 14-19, 20-25 and 26-31 with all common areas and escape routes found to be free of combustibles and residents' storage. Care must be taken to avoid obstructing or blocking fire exit routes and this area must be monitored at all times.</p> <p>Housekeeping was found to be of a poor standard at the time of this assessment within entrance 1-4 and 32-34 with the communal areas and escape routes congested with residents' possessions and storage. It is recommended that the client arrange for the communal areas to be cleared as a priority and all residents reminded of the importance of maintaining sterile communal areas and escape routes.</p> <p>Waste is well managed with paladin style bins located in the carpark.</p> | | |

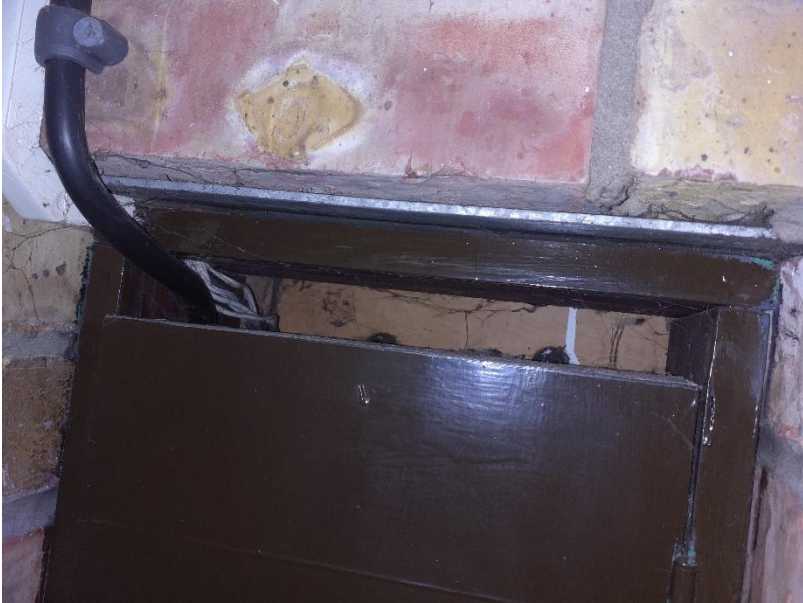
| <p>03</p> | <p>It was noted during this fire risk assessment that the identified communal area doors had the following deficiencies:</p> <ul style="list-style-type: none"> <li>• Electrical riser doors not sufficient in all blocks</li> <li>• First floor lobby door in 32-34 had door damage from loose screws in the hinge putting a strain on the door and frame</li> </ul> <p>It is essential that each door communicating with the means of escape is a suitable fire door, providing a minimum of thirty minutes fire resistance, hung on three grade 13 hinges, combine cold smoke and intumescent seal, "Fire Door Keep Locked" or "Fire Door Keep Shut" signage where appropriate along with having a functioning self-closing device fitted that positively closes the door flush to the frame if a lobby door. It is recommended therefore that the RP instruct a suitably qualified and competent contractor to conduct a fire door inspection to all communal area doors providing advice on suitability as per "Fire Resisting Doors - 62.17" of Fire Safety in Purpose-Built Block of Flats. Any shortcomings identified by this inspection should be addressed as a priority by upgrading or replacing the door.</p> <p>Flat entrance doors, communal area doors, the seals and the self-closing devices should then be subjected to an annual inspection and maintenance schedule.</p> | <p>1</p> | <p>B</p> | <p>Action required</p> <p>SSE have been asked to either remove meters and cabling causing obstruction to doors or provide suitable fire stopping for their meter boards.</p> |

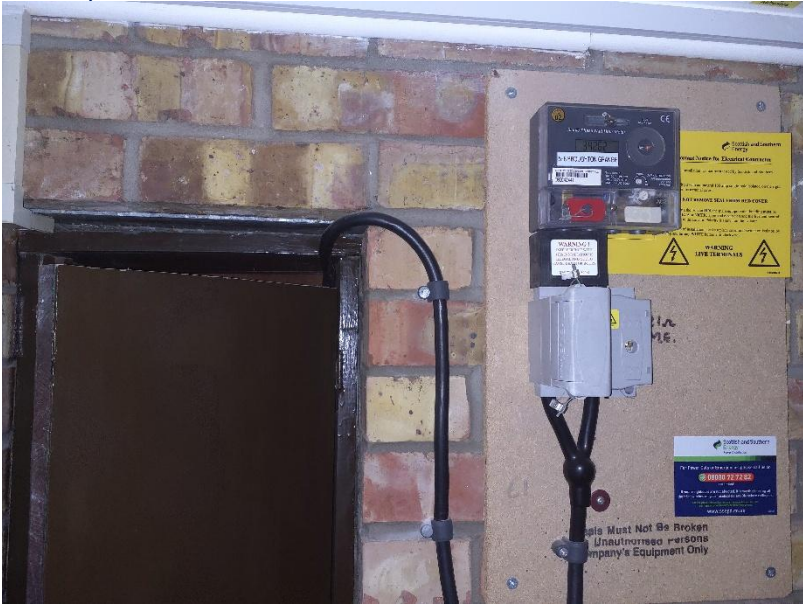
| 05 | <p>It was noted during this fire risk assessment that multiple fuseboards were exposed to the means of escape within multiple blocks which could compromise the means of escape with smoke and fire. It is therefore recommended that the RP instructs a suitably qualified and competent contractor to encase the electrics in either metal or a suitable compound capable of providing a minimum of 30 minutes fire resistance in order to protect the means of escape.</p> | 1 | B | <p>Ongoing action</p> <p>SSE have been asked to undertake remedial to their cabling and meter boards</p> |

| <p>It was noted during this fire risk assessment that multiple fuseboards were exposed to the means of escape within multiple blocks which could compromise the means of escape with smoke and fire. It is therefore recommended that the RP instructs a suitably qualified and competent contractor to encase the electrics in either metal or a suitable compound capable of providing a minimum of 30 minutes fire resistance in order to protect the means of escape.</p> <p>It was noted during this fire risk assessment that there were breaches in the compartmentation in the following areas:</p> <ul style="list-style-type: none"><li>• Multiple electrical risers had breaches in all blocks</li></ul> <p>It is therefore recommended that the RP instructs a suitably qualified and competent contractor to repair the breaches with a suitable compound capable of providing a minimum of 30 minutes fire resistance in order to minimise the likelihood of fire spread and to protect the means of escape as per Section 17 “Compartmentation” in Fire Safety in Purpose-Built Block of Flats.</p> | | |

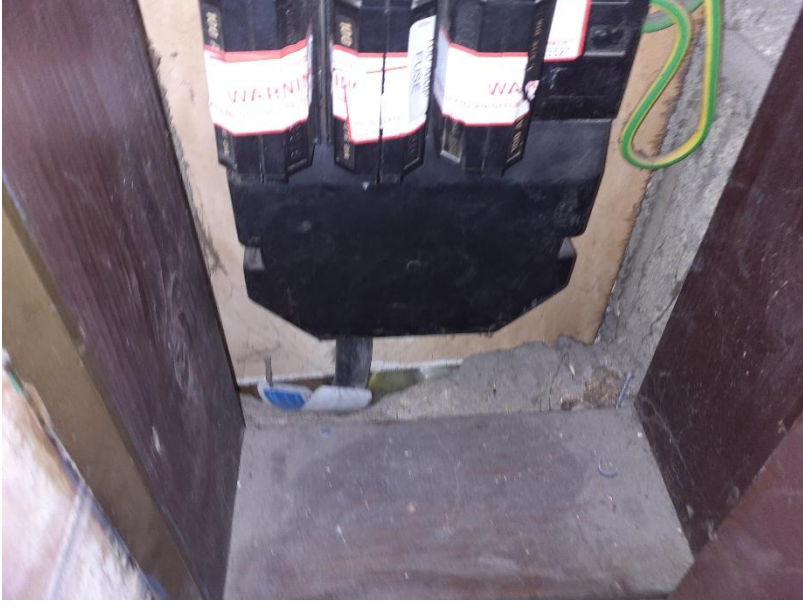
| 06 | <p>It was noted during this fire risk assessment that there were breaches in the compartmentation in the following areas:</p> <ul style="list-style-type: none"> <li>Multiple electrical risers had breaches in all blocks</li> </ul> <p>It is therefore recommended that the RP instructs a suitably qualified and competent contractor to repair the breaches with a suitable compound capable of providing a minimum of 30 minutes fire resistance in order to minimise the likelihood of fire spread and to protect the means of escape as per Section 17 "Compartmentation" in Fire Safety in Purpose-Built Block of Flats.</p> | 2 | B | <p>Ongoing action required</p> <p>As above</p> |
